## 2.0 Introduction

The purpose of this chapter is to provide a summary of the existing conditions of the Freeway Corridor Specific Plan project site. The outcome of this process was a deeper understanding of the issues, constraints, and the opportunities facing the development of the Plan.

City of Yucaipa  
**Freeway Corridor Specific Plan**  
Chapter 2: Existing Conditions

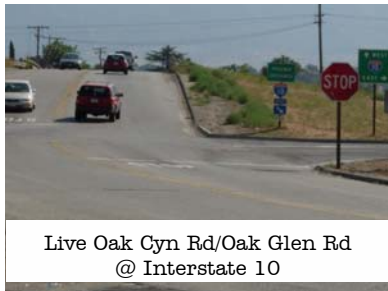
*Live Oak Canyon Road/Oak Glen Road*

Live Oak Canyon Road/Oak Glen Road is a two-to four-lane arterial roadway running on a northeast/ southwest alignment located adjacent to and north of the project site. The roadway is mostly divided by a double yellow center line. Live Oak Canyon Road/Oak Glen Road begins in the County of Riverside and extends northeast and loops around the City and ends back in the County of Riverside. The speed limit is posted at 45 mph south of Avenue E and 40 mph north of Avenue E. Parking is generally not permitted along most of the roadway. Land uses along the roadway are mostly commercial and residential with some vacant lots. Live Oak Canyon/Oak Glen Road is uncontrolled at, but provides boulevard stops for Outer Highway 10S, the I-10 Westbound Ramp, and Colorado Street. The roadway is controlled by a 4-way stop sign at the I-10 Eastbound Ramp and traffic signals at Avenue E and Yucaipa Boulevard.

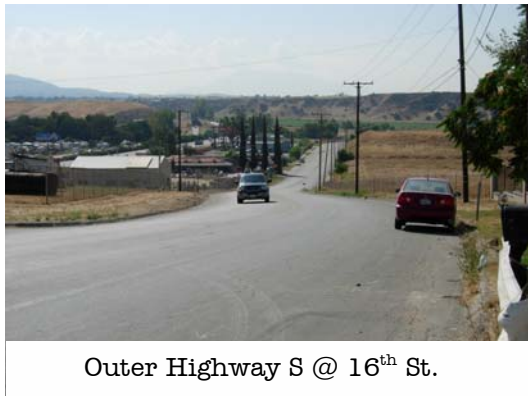
*Outer Highway 10S*

Outer Highway 10S is a two-lane arterial roadway running on an east/west alignment located adjacent to and north of the project site. The roadway is mostly divided by a double yellow center line. Outer Highway 10S begins at Live Oak Canyon Road and continues west where it ends at Gold Hill Lane. The speed limit is posted at 40 mph. Parking is generally not permitted along most of the roadway. Land uses along the roadway within the study area are mostly vacant lots with some commercial and residential. Outer Highway 10S provides boulevard stops for Alta Vista Drive and 16<sup>th</sup> Street. The roadway is controlled by a 3-way stop sign at Yucaipa Boulevard and a boulevard stop at Live Oak Canyon Road/Glen Oak Road.

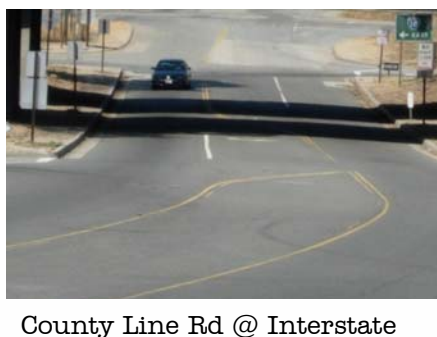
*County Line Road*

County Line Road is a two-lane arterial roadway running on an east/west alignment located adjacent to and south of the project site. The roadway is mostly divided by a double yellow center line. County Line Road begins just east of Canyon Crest Road and extends east where it ends approximately one-half mile west of Crow Street. The speed limit is posted at 35 mph east of the I-10 Freeway and 25 mph west of the I-10 Freeway. Parking is generally not permitted along most of the roadway. Land uses

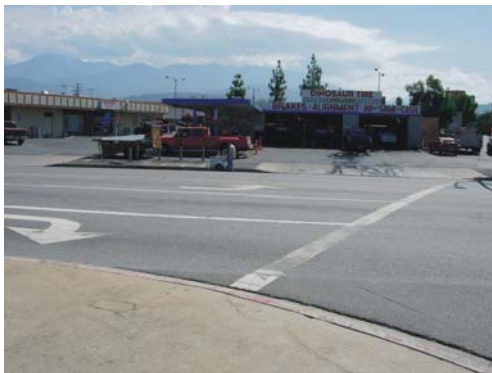
*Calimesa Boulevard*

Calimesa Boulevard is a two-to four-lane arterial roadway running on a northwest/southeast alignment located through the northern portion of the project site. In the project area, it runs parallel and just north of Interstate 10. The roadway provides two travel lanes and is divided by a double yellow center line north of County Line Road. South of County Line Road, Calimesa Boulevard widens to provide four travel lanes, two in each direction, divided by a two-way left-turn lane. Calimesa Boulevard begins in the County of Riverside and extends northwest where it turns into 14<sup>th</sup> Street at Oak Glen Road. The speed limit is mostly posted at 50 mph north of County Line Road and 35 mph south of County Line Road. Parking is generally not permitted along most of the roadway. Land uses along the roadway are mostly vacant lots with some residential north of County Line Road. South of County Line Road, the land uses along Calimesa Boulevard are mostly commercial. Calimesa Boulevard provides a boulevard stop for Wildwood Canyon Road. The roadway is controlled by traffic signals at Oak Glen Road and County Line Road.

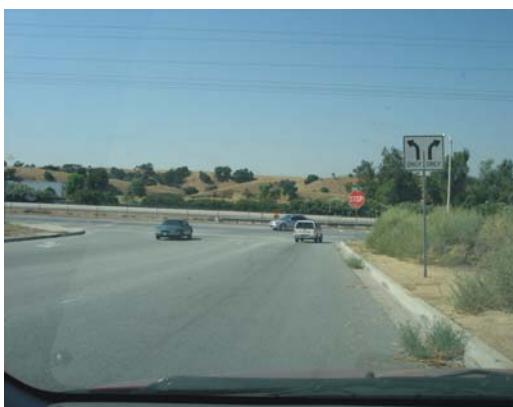
*Wildwood Canyon Road*

Wildwood Canyon Road is a two-lane arterial roadway running on an east/west alignment adjacent to and north of the project site. The roadway is marked by a double yellow center line and the speed limit is posted at 40 mph along most of the roadway. The roadway extends east from Calimesa Boulevard and ends at Oak Glen Road. Land uses along Wildwood Canyon Road are mostly residential with some vacant lots. Wildwood Canyon Road provides a boulevard stop for Colorado Street. Wildwood Canyon Road is controlled by a boulevard stop at Calimesa Boulevard and an all-way stop sign at 5<sup>th</sup> Street.

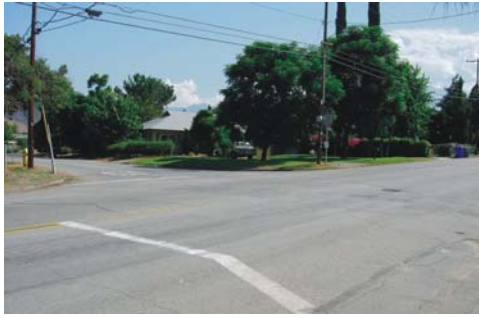
Colorado St. @ 9<sup>th</sup> St.

Colorado Street is a two-lane collector roadway running on an east/west alignment adjacent to and north of the project site. The roadway is divided by a double yellow center line. Colorado Street begins at Oak Glen Road and continues east to Wildwood Canyon Road. The speed limit is posted at 35 mph. Parking is permitted along most of the roadway. Land uses along the roadway are mostly residential. The roadway is controlled by an all-way stop sign at 8<sup>th</sup>, 9<sup>th</sup> and 10<sup>th</sup> Street and a boulevard stop at Wildwood Canyon Road.

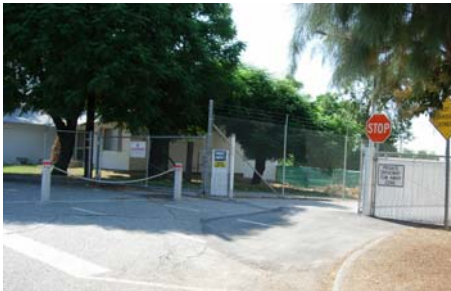
9<sup>th</sup> St. @ Colorado St

9<sup>th</sup> Street is a two-lane collector residential roadway running on a north/south alignment adjacent to and north of the project site. The roadway is unmarked and extends south from Washington Drive and ends approximately 200 feet south of Colorado Street in the project area. The speed limit is not posted, so a prima facie speed limit of 25 mph would apply. Land uses along the roadway are mostly residential. The roadway is controlled with an all-way stop sign at the intersection of Colorado Street.

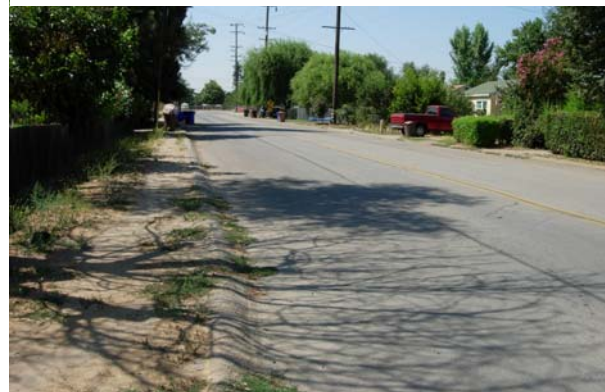
16<sup>th</sup> St @ Ave. E

16<sup>th</sup> Street is a two-lane collector street running on a north/south alignment approximately one-quarter mile west of the project site. The roadway is divided by a double yellow center line and broken yellow center line along various sections of the roadway. 16<sup>th</sup> Street begins at Outer Highway 10S and continues north where it ends at Sand Canyon Road. The speed limit is posted at 35 mph and 40 mph along various sections of the roadway. Parking is generally permitted along most of the roadway. Land uses along the roadway are mostly residential with some vacant lots. 16<sup>th</sup> Street provides a boulevard stop for Avenue E. The roadway is controlled by boulevard stops at Outer Highway 10S and Yucaipa Boulevard.
